United States Department of the Interior
National Park ServiceNational Register of Historic Places
Registration Form

historic name **Union Station**other names/site number **Concord Junction Depot**

street & number **20 Commonwealth Avenue**

city, town **Concord**

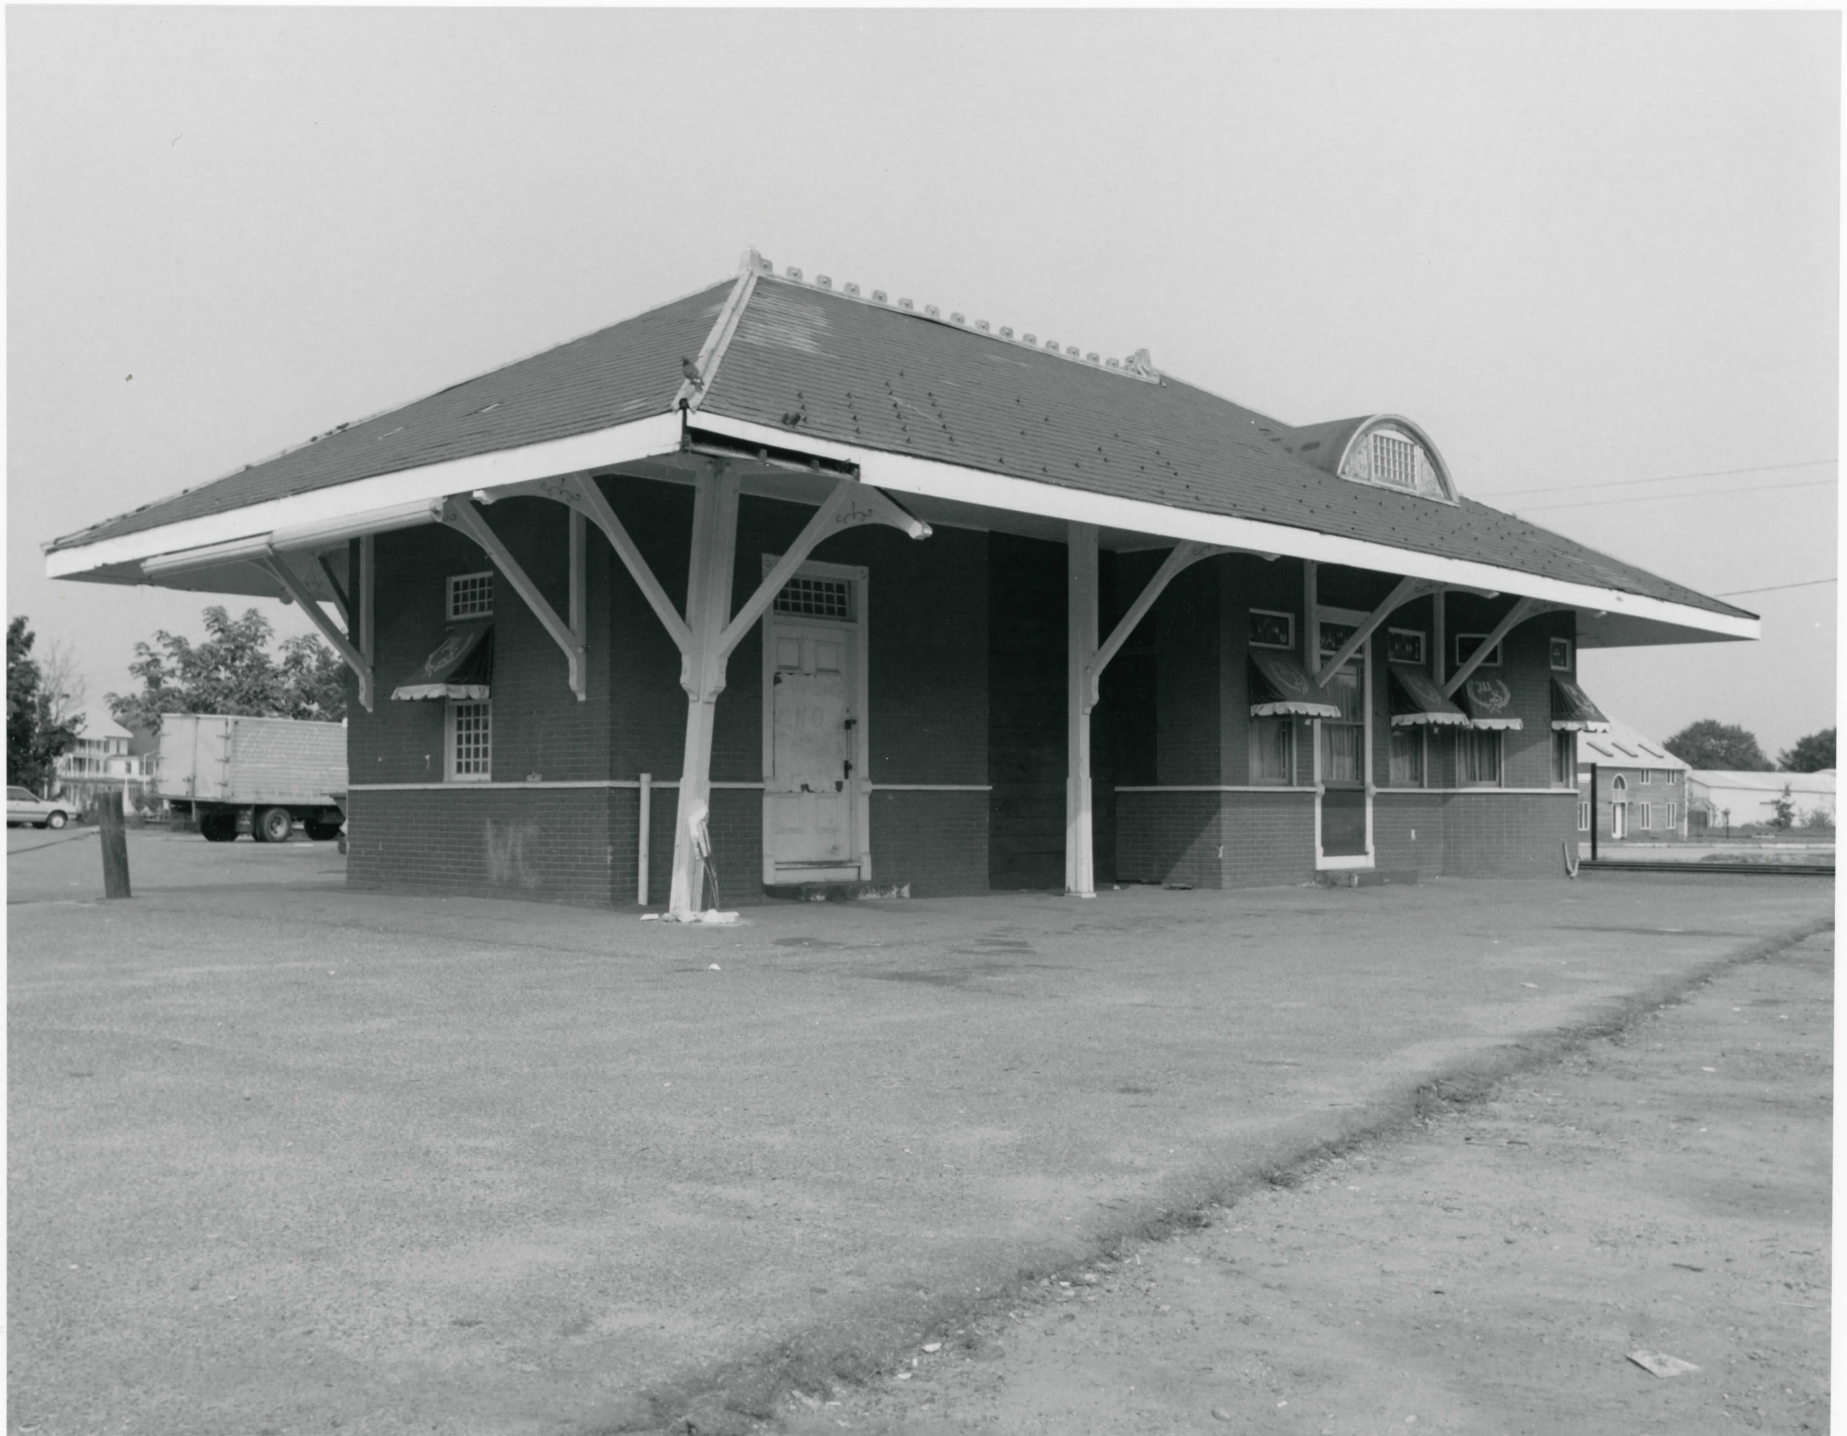
Photograph #1 of 3

View facing northwest, showing south and east elevations

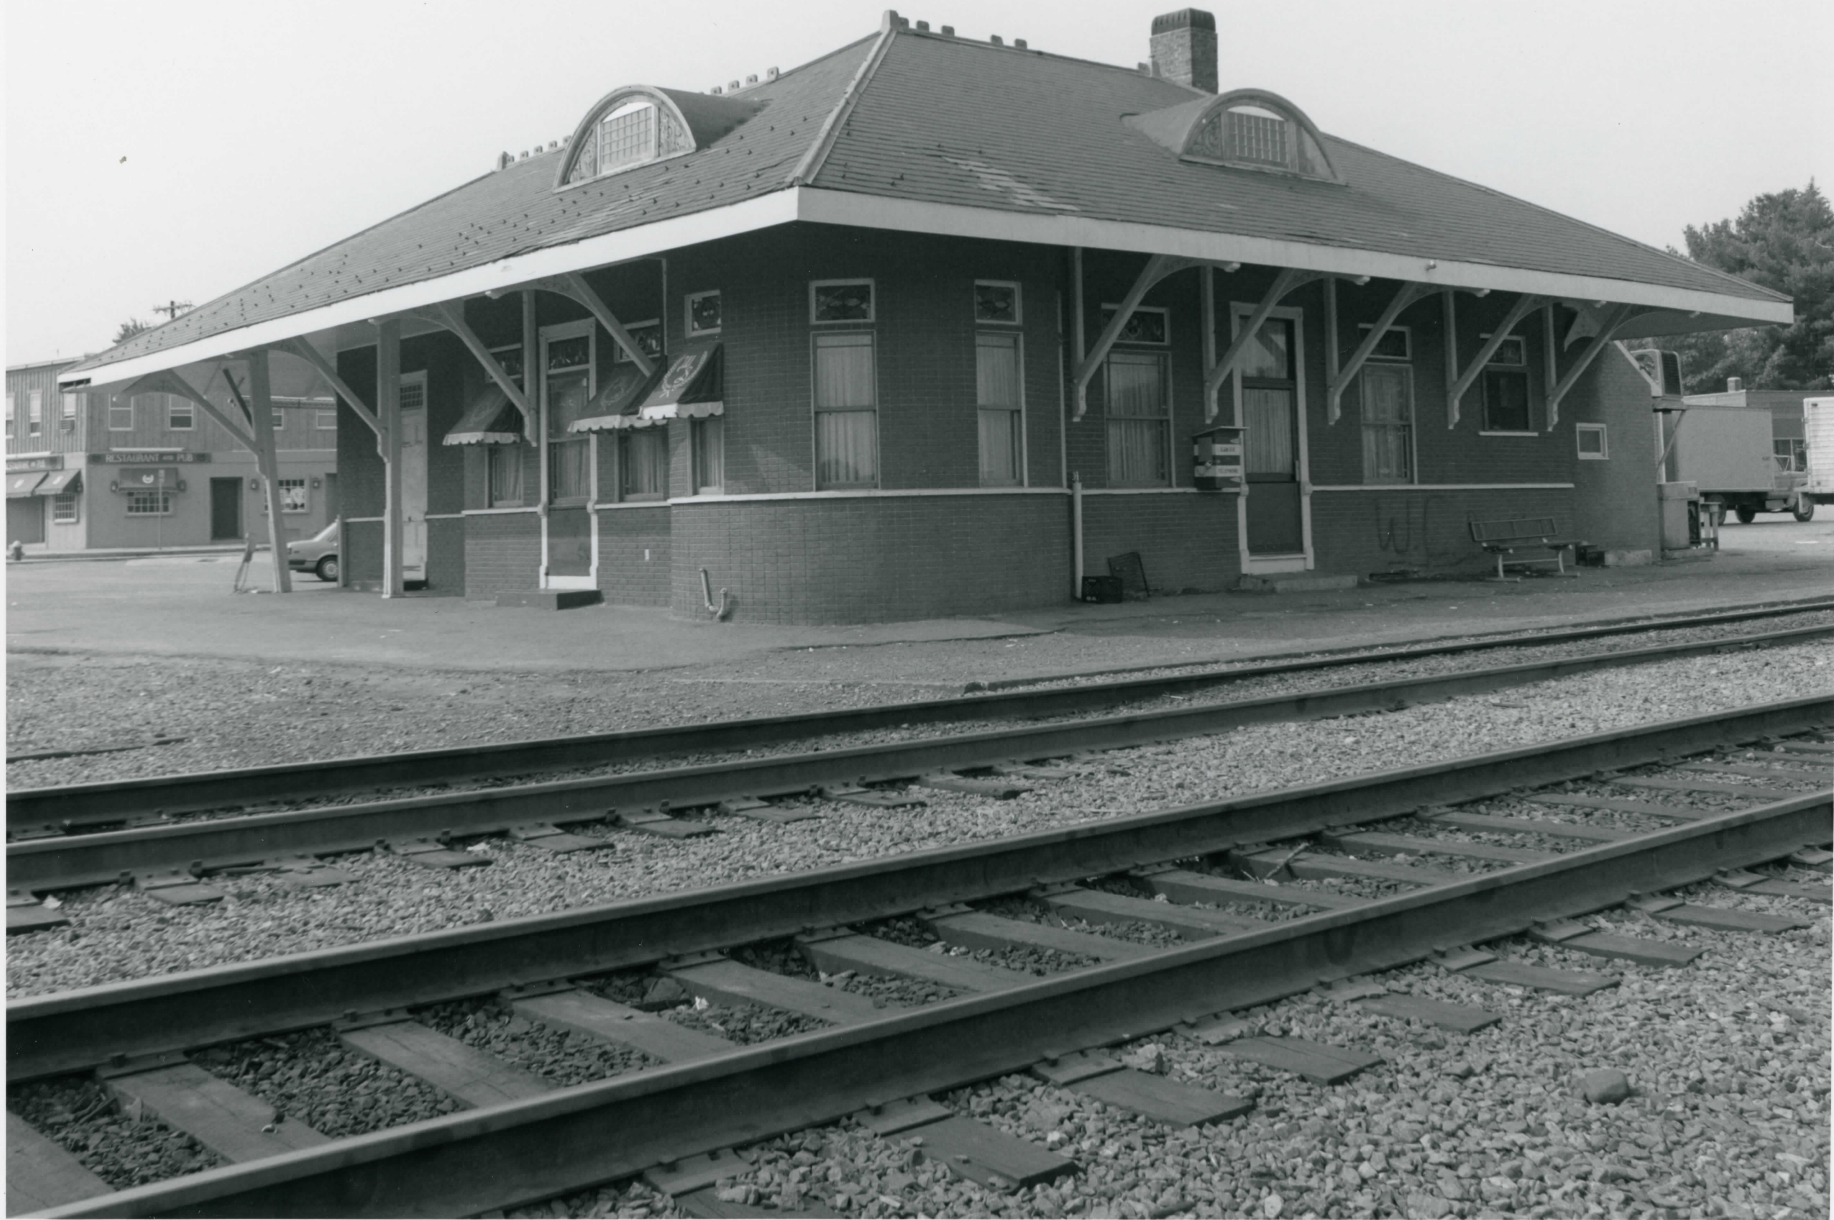
Photograph #2 of 3

View of north and east elevations facing southwest.

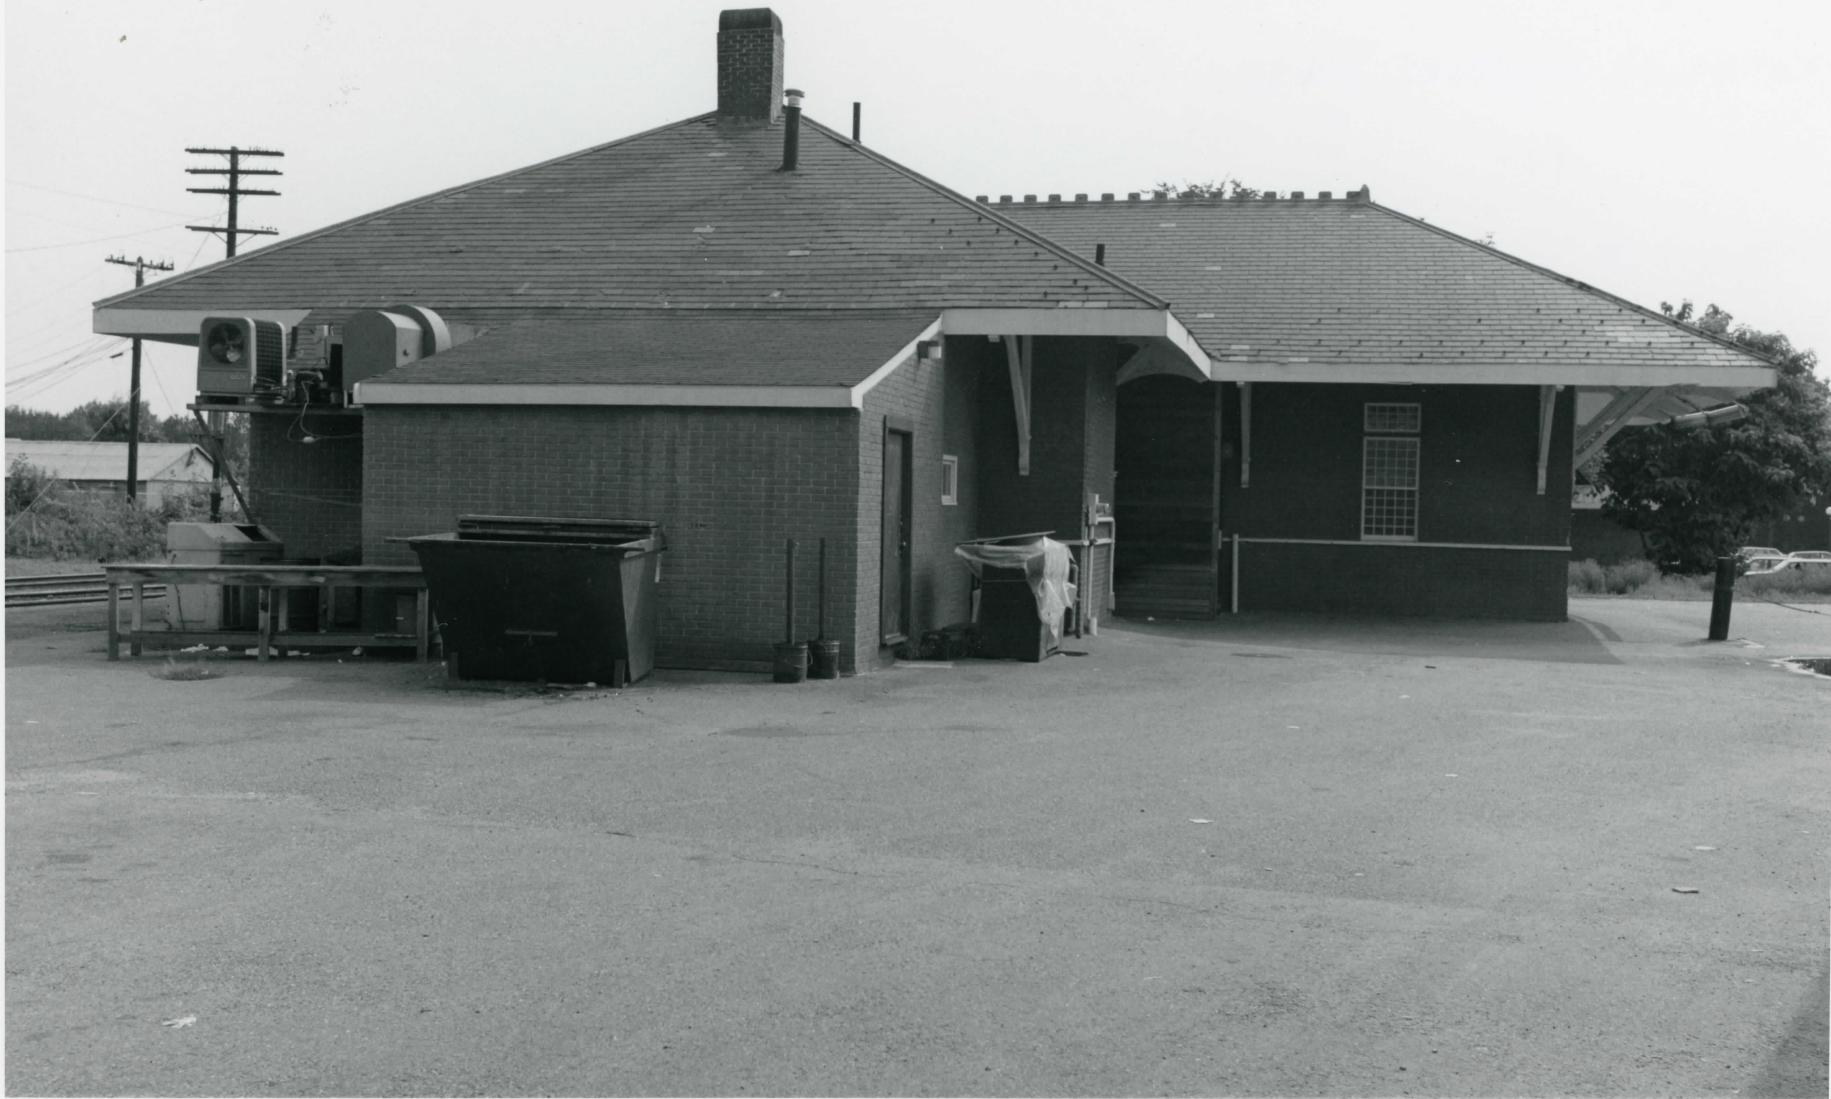
Photograph # 3 of 3

View of west and south elevations facing east
